## Chapter 8 – Naiad repair

One of the primary reasons for lifting the boat in September of 2016 was to do a full evaluation and service of our Naiad hydraulic stabilizer system.

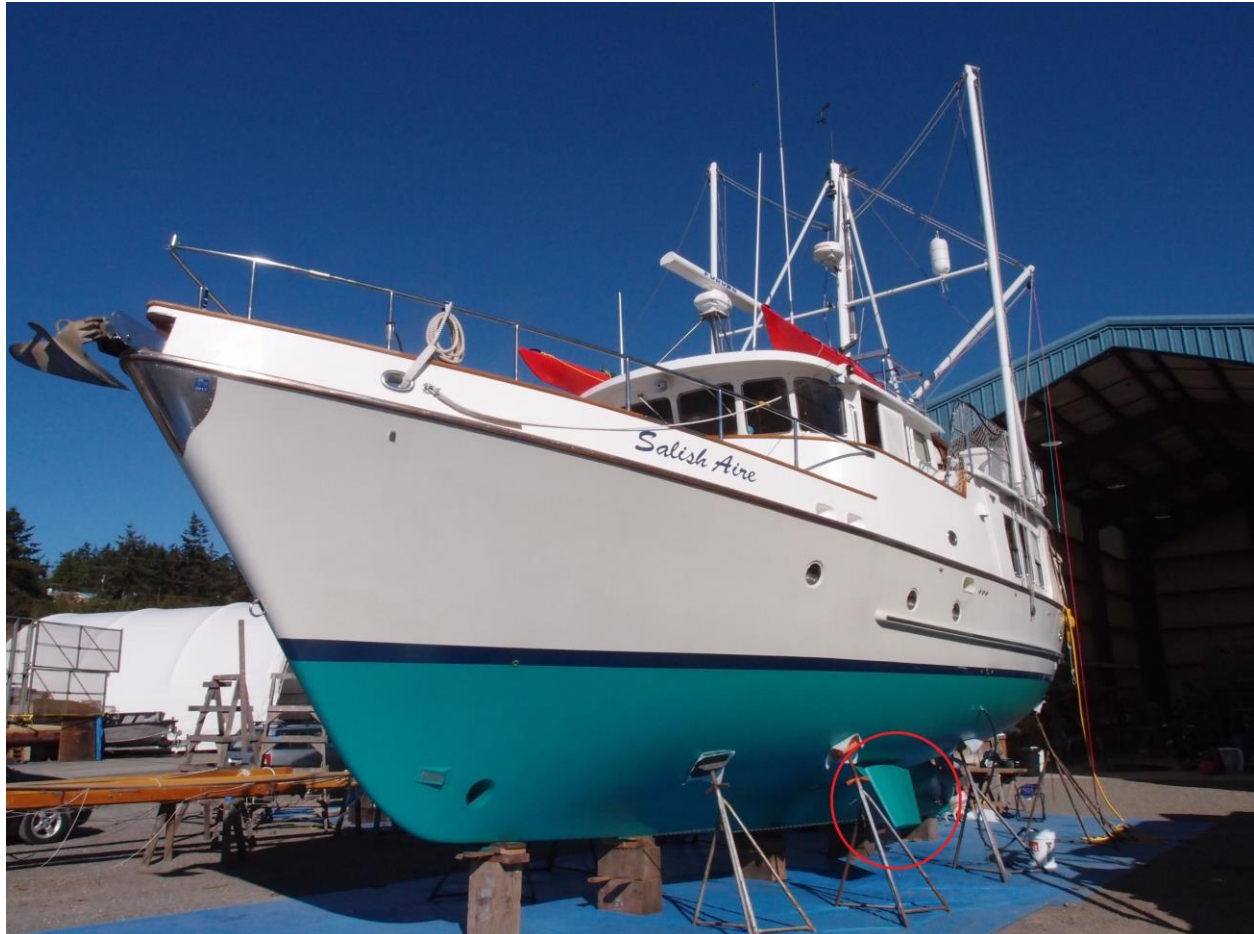
Figure 1: Naiad port side fin circled in red

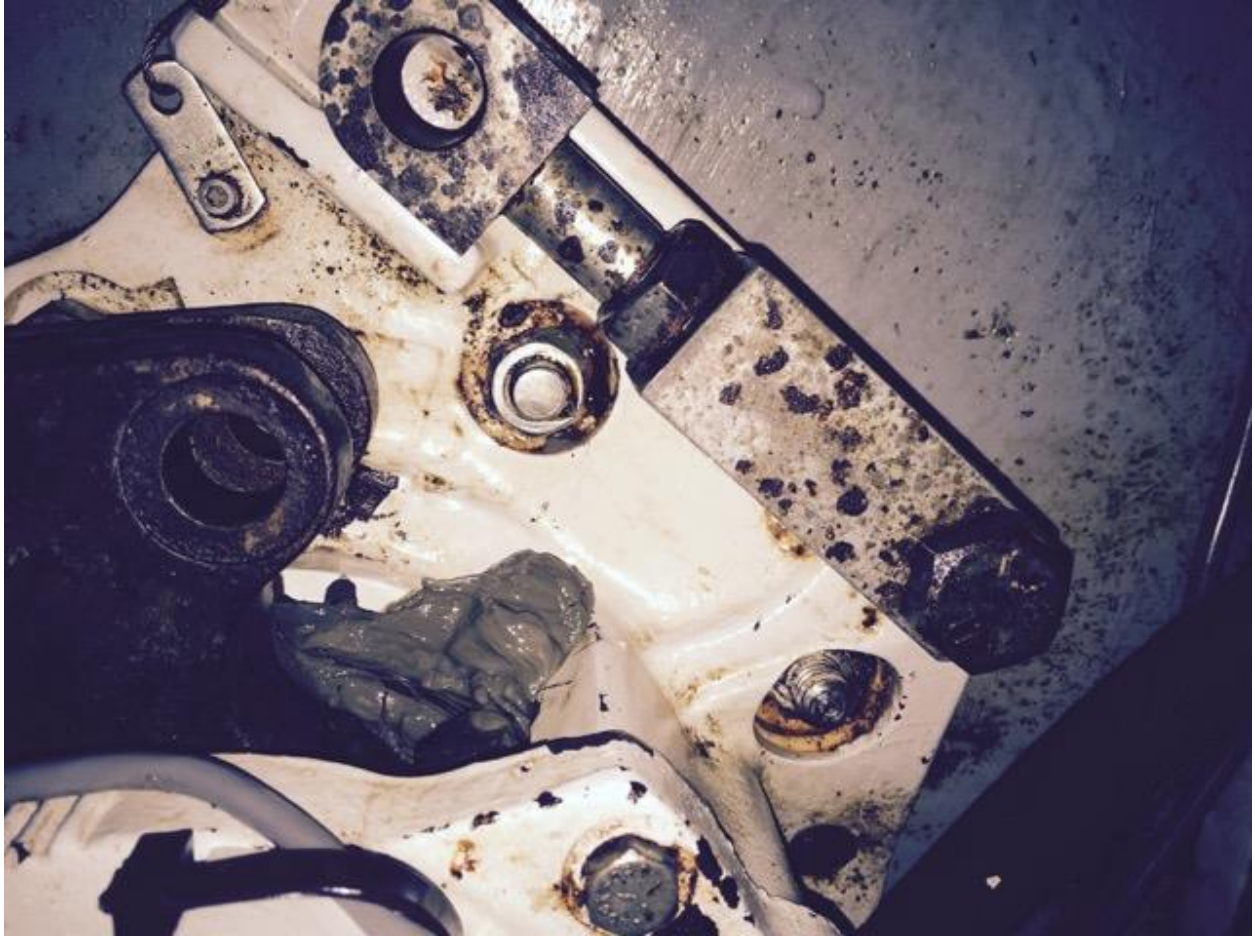
Figure 2: (NOT Salish Aire) - but an example of grease being forced out of the actuator into the boat as a classic warning sign of water intrusion below

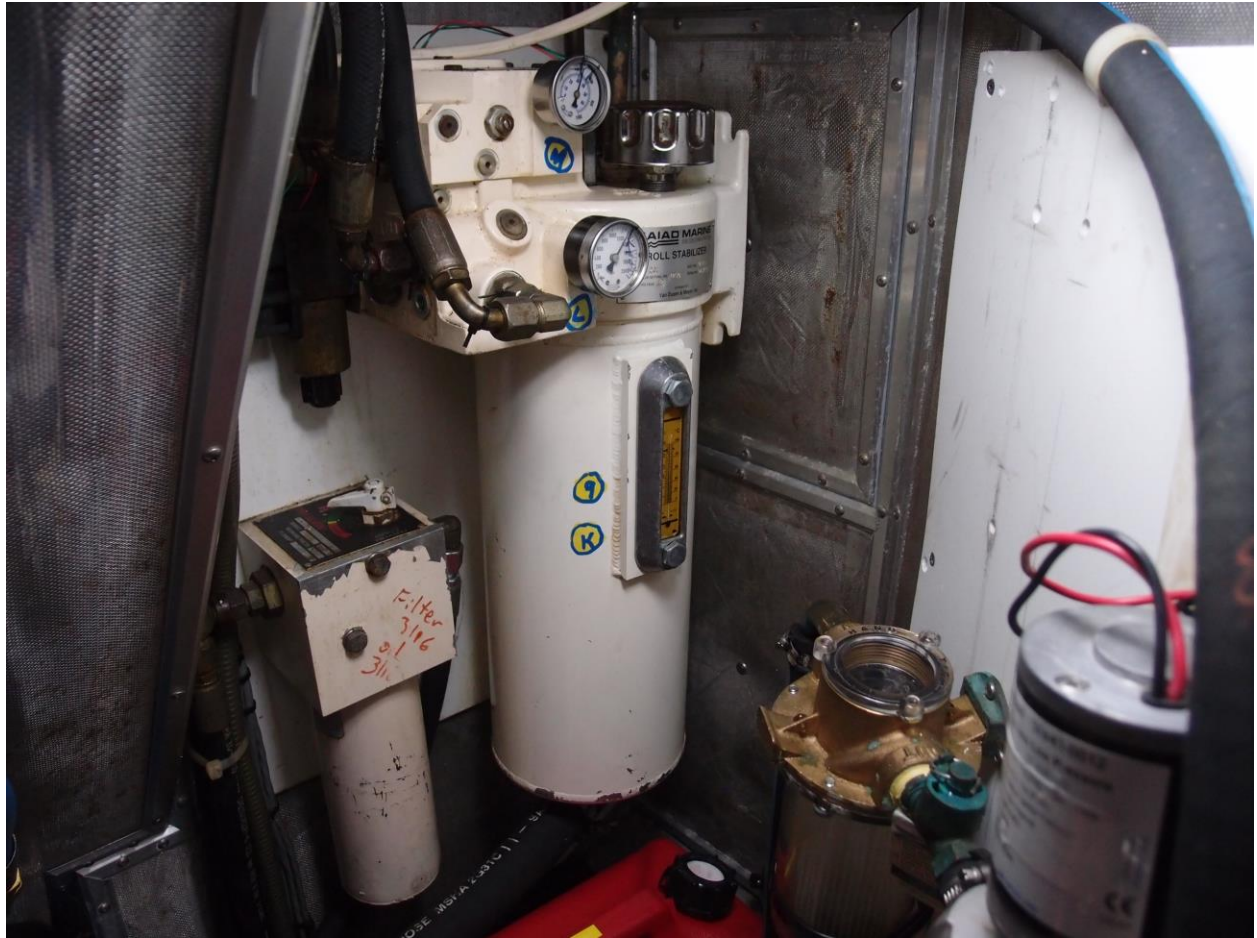
Figure 4: Naiad reservoir with new thermometer / level sight gauge installed

So far I have installed an aftermarket pressure gauge to replace the non-functioning gyro gauge. I have removed and taken apart the oil reservoir and replaced the thermometer on the front of the reservoir as well as the overtemp and underfill electrical switch assembly from inside of the unit. Takedown, cleaning, reassembly, and lifting it back into the difficult to reach corner where it is mounted to the better part of 2 days.

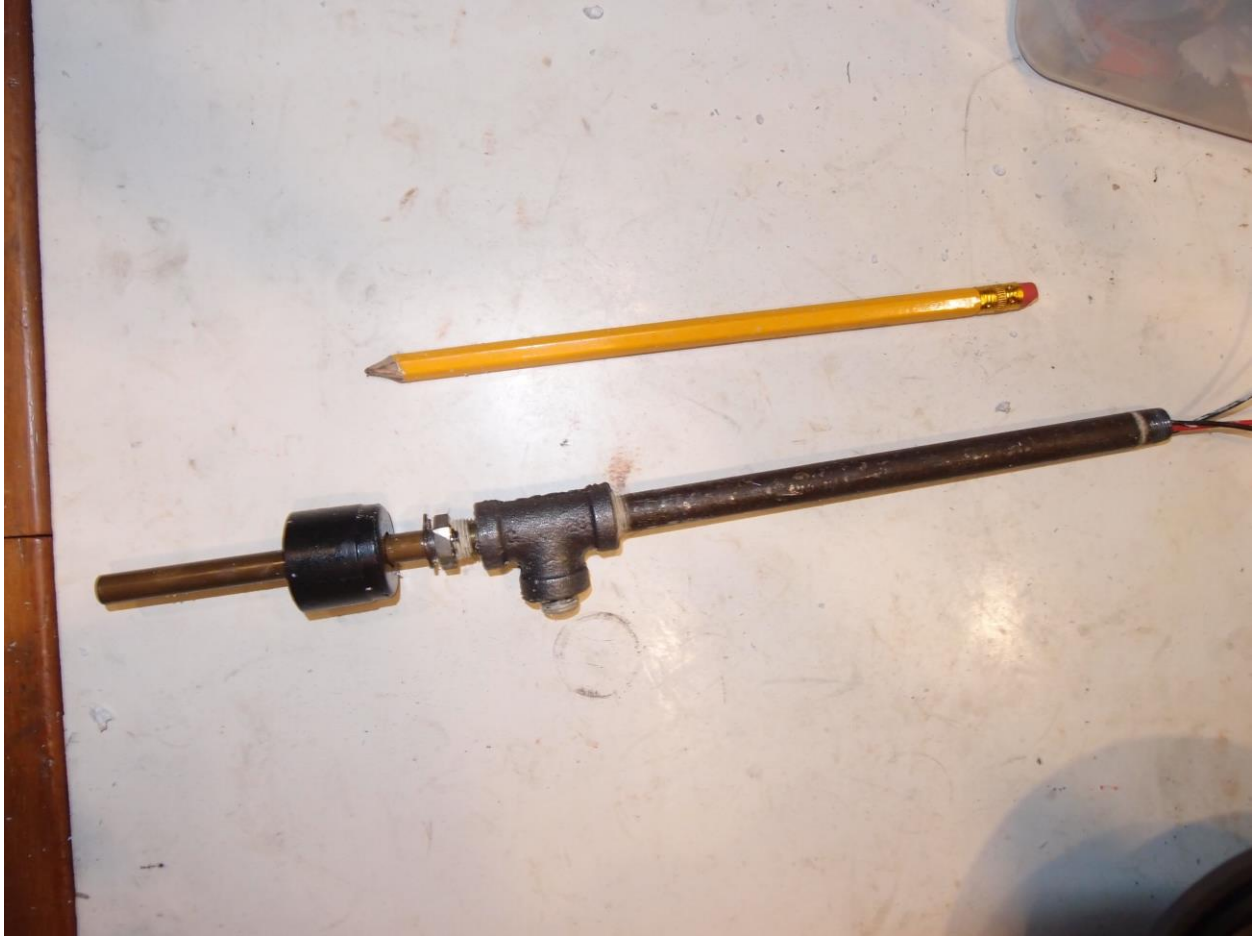
Figure 5: sender unit with oil level and over temp sensors that goes in the center of the reservoir

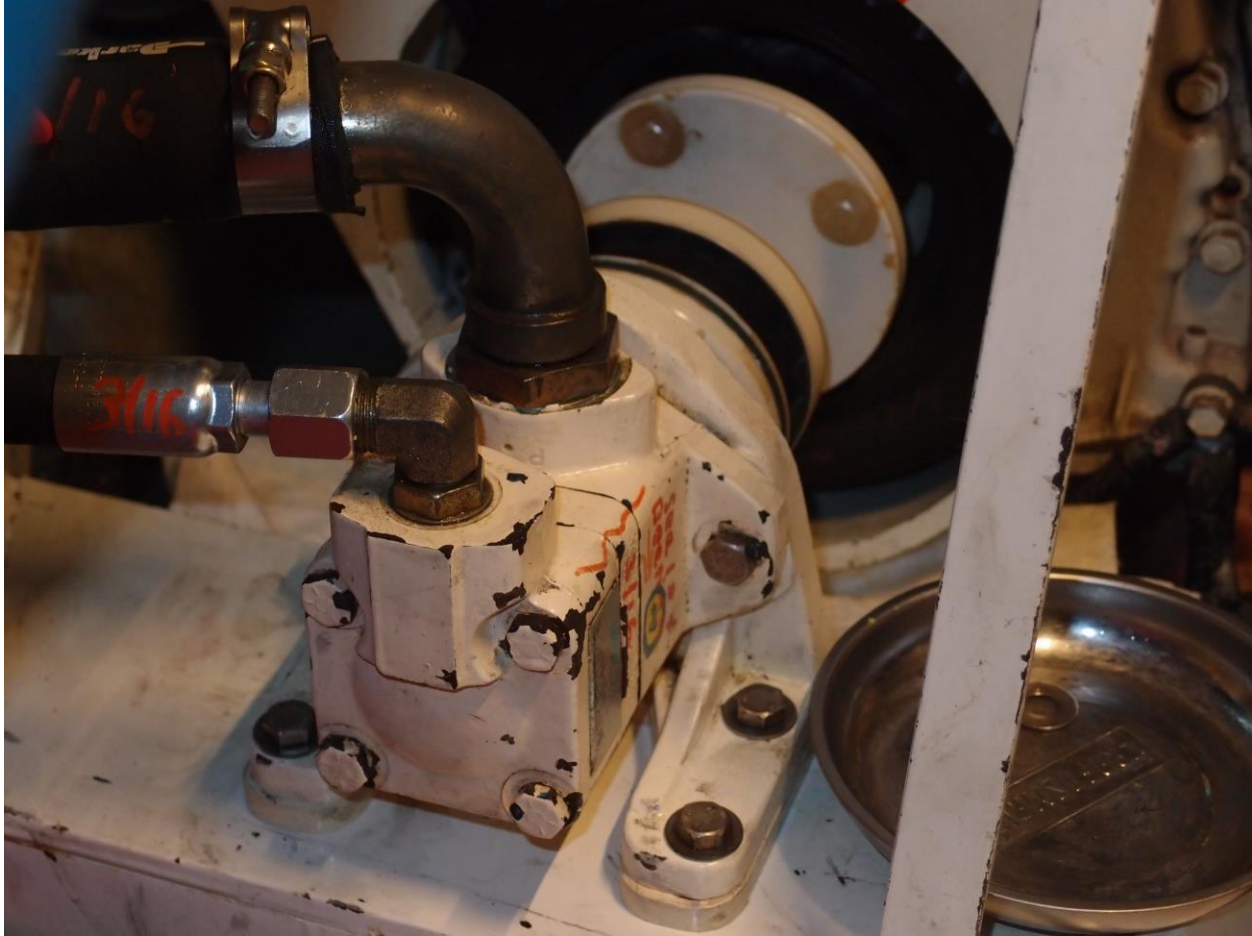
Figure 6: Vickers hydraulic pump driven directly off the front pulley of the Lugger

I had previously replaced the seals in the leaking hydraulic pump and replace the high and low pressure hoses from the pump to the reservoir. I was able to source the replacement parts kit from the internet as this is a common industrial pump. A local bearing supply dealer had a replacement rubber insert for the drive coupling.

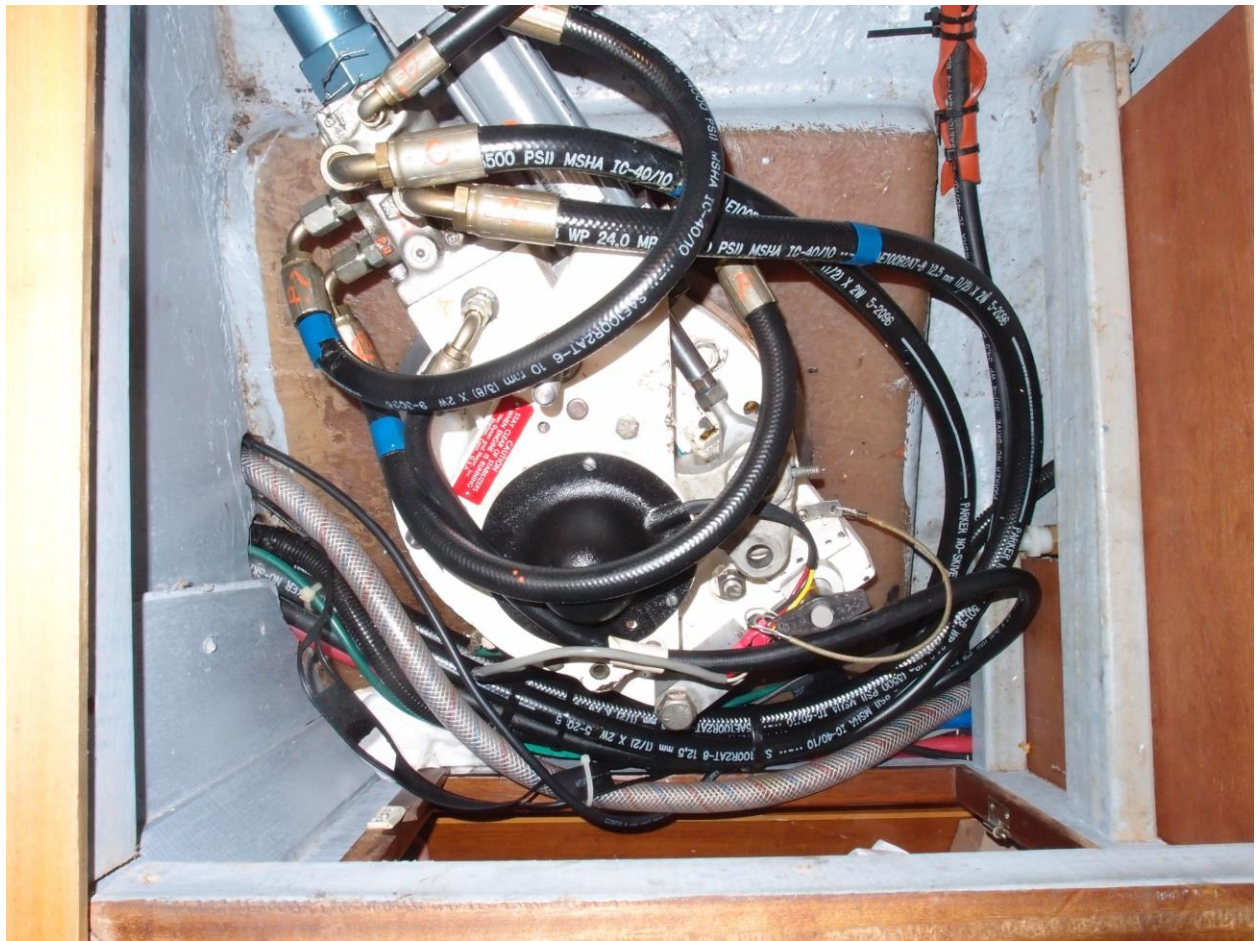
Figure 7: Fully assembled upper end port side.

Getting to the top of the fin assemblies inside of the boat takes some minor disassembly of the bed in the guest stateroom and the vanity in the aft head. Once the panels/furniture are removed it is pretty easy to reach the parts. The first thing I wanted to do was to replace the seals in the hydraulic cylinders as I was quite sure that the shaft seals were the source of the oil on top of the assemblies. I figured if I was removing and disassembling the cylinders anyway then I might as well install full seal kits. Naiad charged me about \$70 per kit (X2) for kits that contained 4 seals each. When I looked carefully I realized only one of the seals fit my cylinders – luckily it was the lip seals that I suspect were leaking. Just to be sure I had the correct parts I called Naiad customer service. To summarize: I have gray colored cylinders made by Van Dusen and Meyer company who is long out of business. Naiad cannot get the correct seal kits any longer and it was just luck that the one seal I needed was included in the kit. The Naiad rep and I talked about replacing the cylinders for about \$800 each or if it was reasonable to try the lip seal and then pressure test the cylinders to see what happens. I put everything back together with the new lip seals and then devised a bench test rig using Clarice's father's hydraulic hand pump. There was no sign of leakage with the testing and so I do plan to reinstall the original cylinders. Finally, since the kits came with a Parker number on them (RK2AHL0061) I sourced a second set on the internet for \$9 each and ordered an extra set to have on hand. Clearly cost control on a job like this is a challenge.

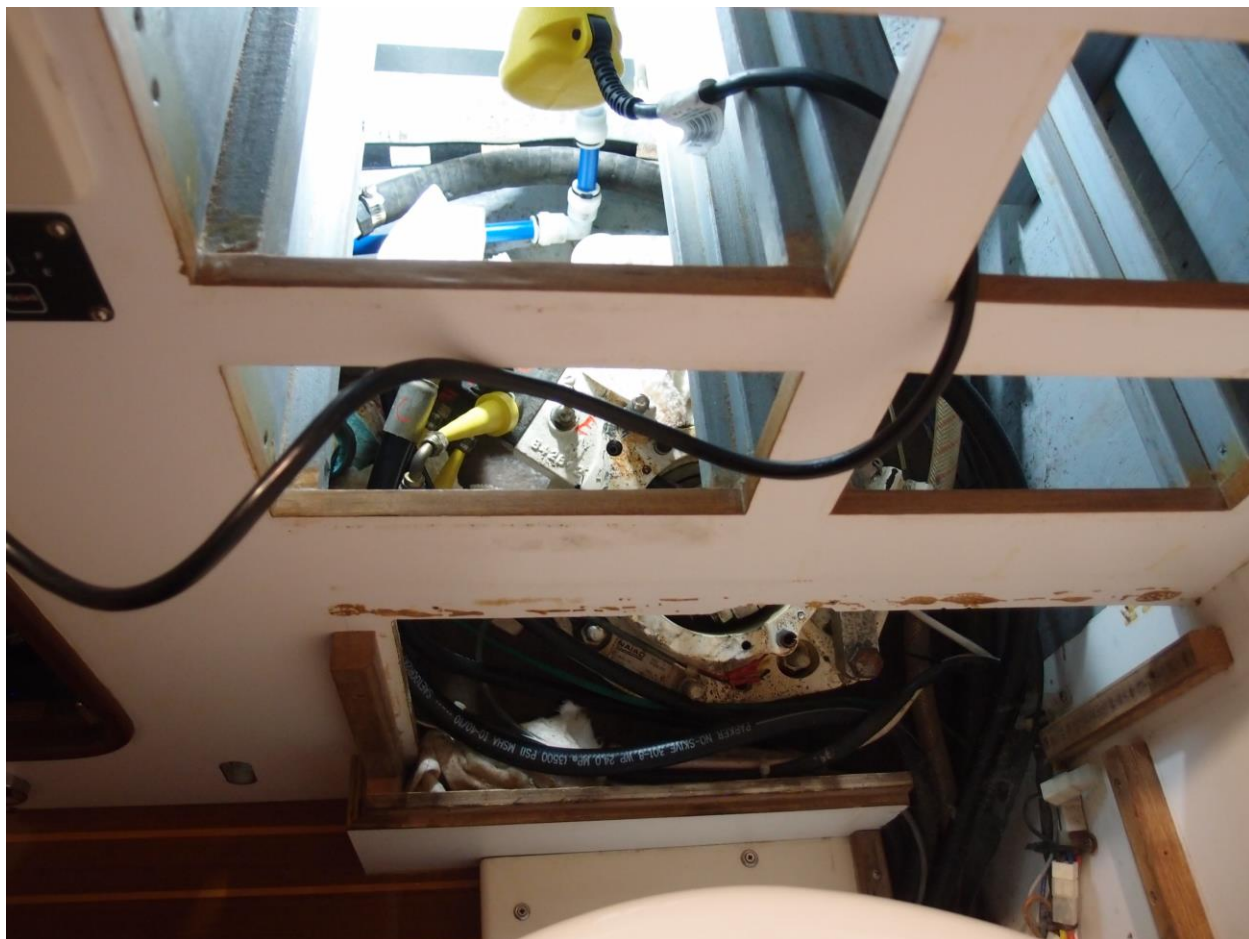
Figure 8: Partially disassembled Stbd side unit - access is a bit more of a challenge as it is under the vanity in the aft head

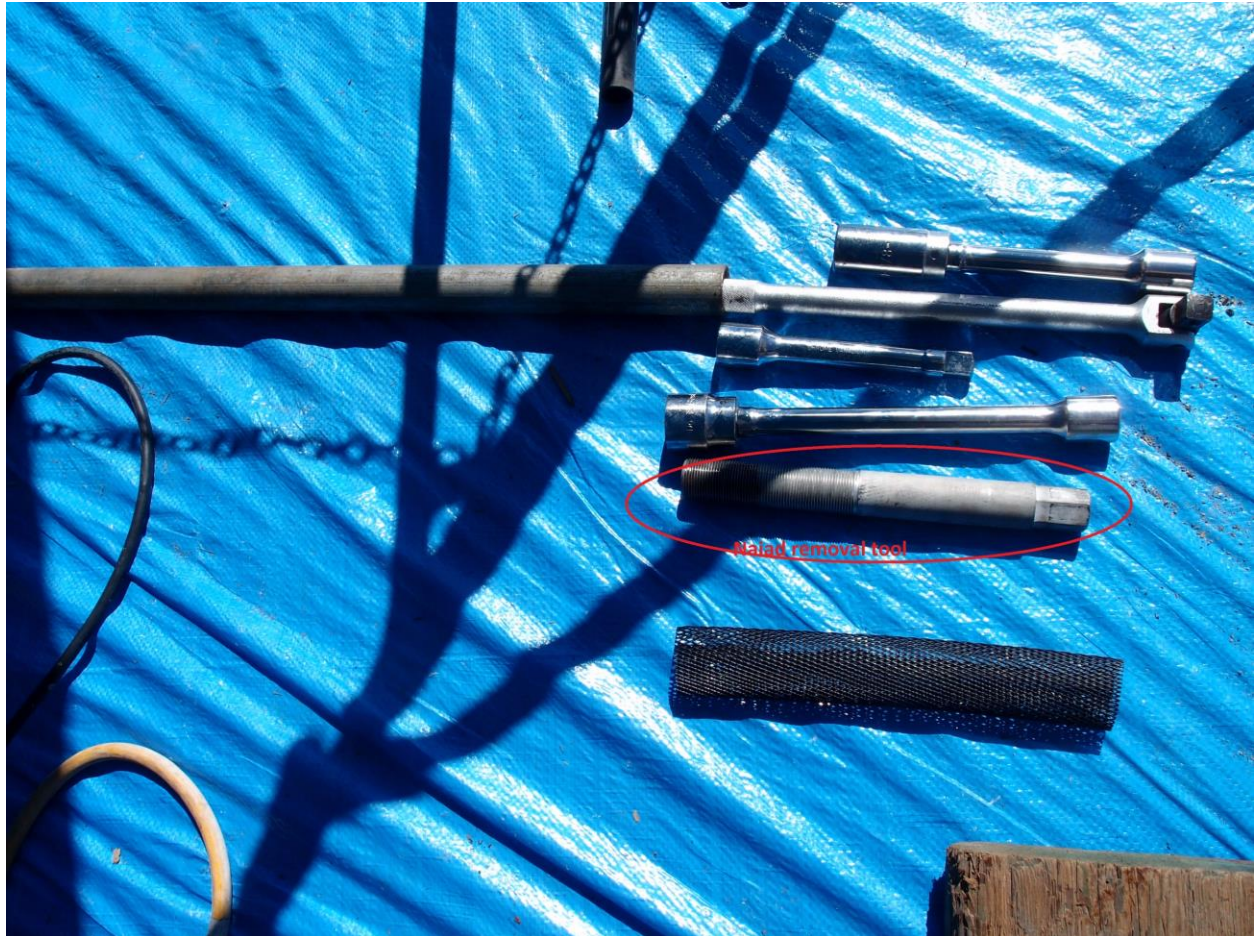
Figure 9: Tools used to remove fins including 3/4 drive breaker bar and extension pipe, 1 3/8 socket, 12 in extension, and Naiad removal tool (circled)

The fins were removed with the manual screw-in tool purchased from Naiad. This is a screw with a socket fitting at one end but I was told by a Naiad company technician at a boat show to not even think about trying to make one as they are specially hardened and if the threads should strip on a home built model the repair costs can be a couple thousand dollars. The first step of the fin removal process is to remove the bolt that holds them on. This takes a 1 3/8 socket, a long extension, and a breaker bar plus a pipe capable of breaking loose a bolt that is initially tightened to 300 ft lbs. Once the bolt is removed the removal tool is threaded into threads in the fin and then tightened until the fin pops loose from its taper fit shaft by pushing on the end of the shaft. In preparation for the sudden drop of the fin blocks are put under it leaving a small bit of free space above the top block. We tightened the tool with a 3/4 drive breaker bar plus about 2 1/2 feet of iron pipe for a leverage extension. The good news is that the tool works much better than we expected and we had both fins down in a short time. (The guy from Haven commented that it was also much tidier than using the hydraulic tool).

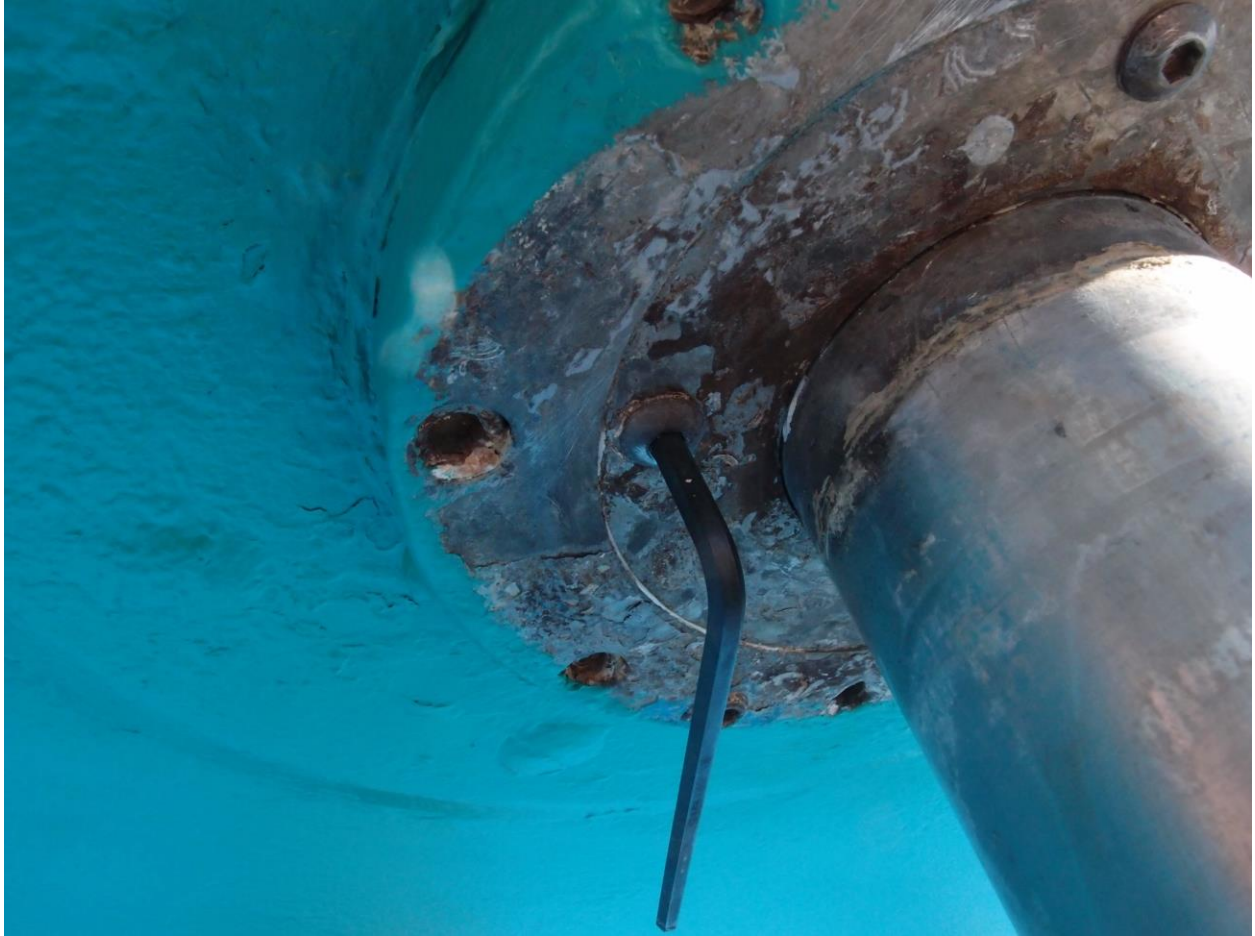
Figure 10: removal of seal cover (inner ring - outer ring is the bearing cover)

I had watched carefully when the outer seals were replaced in 2014 and so getting them out was pretty straight forward. They are held in place with a cover which is held in with 4 Allen screws. To get the seals out (they are a stacked set of 2) the recommended plan is to drive a long sheet metal screw into both sides of the seal and it will walk itself out. Next is the bearing cover which is held in by several more Allen screws. Since the cover tight fits into a lip in the main casting of the fin assembly it would be really difficult to get out if it weren't for two 3/8 -16 drive screw holes provided by Naiad engineers. The holes are filled with Allen set screws which are removed and then bolts (I used grade 8 to avoid any chance of stripping the threads) are driven into the holes which pushes the cover out. My only concern so far is in finding that the bottom of the main casting has rusted and chipped away a bit. Since the pressure seal is really in the lip there is not a concern it will leak but I am still trying to think of a way to keep it from deteriorating more.

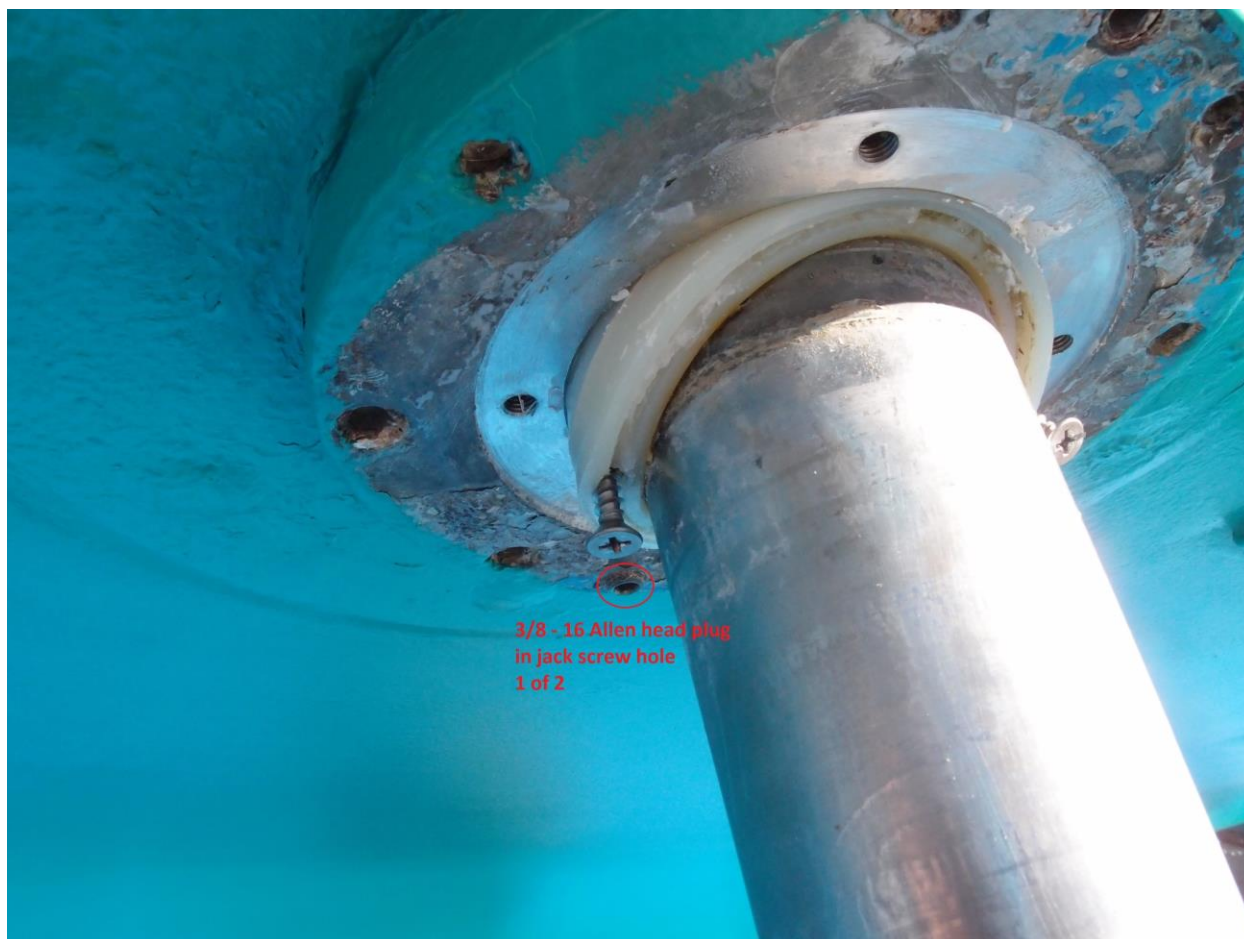
Figure 11: Showing removal of seals using screws (2 stacked seals both with lips down). Also showing location of one of the jack screw holes used to force the bearing cover off.

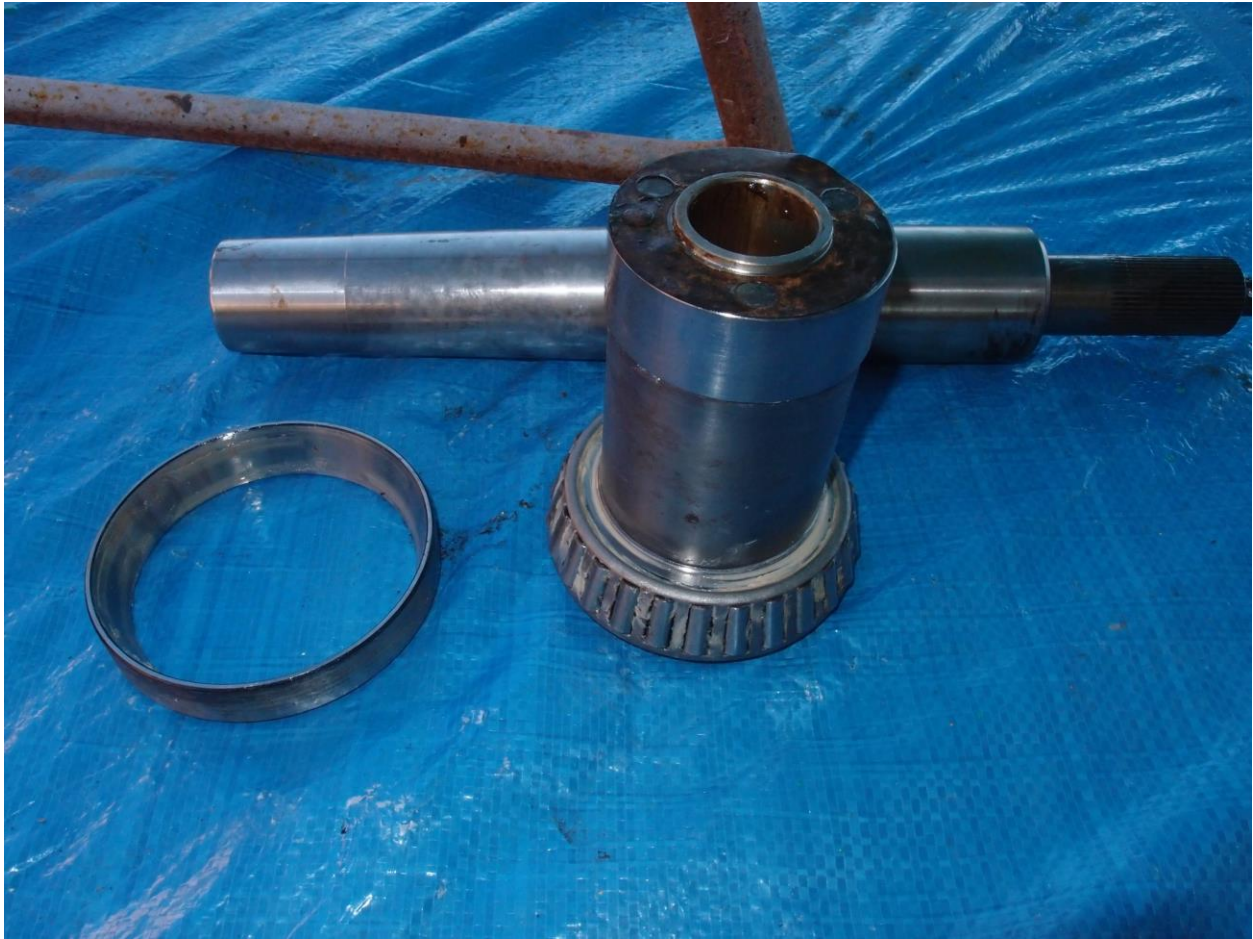
Figure 12: Main shaft that comes out first; bearing shaft with the lower bearing still in place and one of the 2 bearing races. (There is a lip on the bearing shaft that is not visible in this photo that makes it impossible to remove the lower bearing without taking it up the full length of the shaft and off of the top end).

Next I moved from outside of the boat to inside at the top of the fin assembly. I removed the main shaft which is held in by a single loose bolt (it is used for height adjustment) and a clamping assembly that keys onto the top of the shaft and provides the lever arm for the hydraulic cylinder (previously removed) to turn. It is interesting that this is really all that keeps the fins from dropping out of the boat – but clearly it works reliably. The lever arm is held onto the top of the bearing shaft assembly by three bolts and then it lifts off easily. The bearing is held in by a plate that sits firmly inside of the top seal. Again Naiad engineers provided a 3/8 – 16 threaded hole for a jack screw which lifted the cover easily off. Next I used a huge screwdriver as a pry bar to lift out the top seal (this sounds easy but took a bit of banging and levering to accomplish). Now the bearings and bearing shaft are easily in view. When the seals were changed in 2014 I was told that the assembly needed to be taken to a shop for the bearings to be pressed on and the grease loaded. Now that I see how it is assembled – unless the whole casting were removed this is a bunch of hogwash (I won't name a company I am not pleased with for general consumption on the internet but this supports my plan to never use that company again). Bottom line is that the bearing shaft *must* be tapped out of the bearing in order for it to be removed from the boat. I found that tapping it firmly with a brass hammer forced it out of the upper bearing and the shaft and lower bearing dropped out of the bottom of the boat into my wife's waiting hands. The lower bearing comes off the *top* of the shaft and thus must be pressed off its home seat and then the upper bearing seat as well. Haven had a press that made easy work of this step. The final disassembly steps involved using a bar to go on the inner edge of the 2 bearing races and tapping on the bar to force the races out, one

under the boat and one into the boat. Now it was just a matter of wiping out about a pint of white grease so that the reassembly process can begin.

To install the lower bearings on the bearing shafts we heated them with a torch and they dropped right on. I tried using a similar trick to get the races to drop in place by putting them in the boat's freezer but it wasn't enough so they ended up being tapped into place with a hammer and bar. Next the lower bearing was loaded with grease and lifted into the waiting race from under the boat while the bearing cover (already set up with sealant on the sealing surfaces) was put over it (this took 2 people to accomplish) and a couple of bolts started to hold everything in place. The bolts (Allen socket head style) were then treated with Lock Tight and torqued to 15 ft lbs as called out on the Naiad drawings.
